**Subject: Draft Sampling Trip Report for the Riverside Avenue Site  
Newark, Essex County, New Jersey  
Contract: EPA Region 7 START, Region 2 Crossover  
Contract No. EP-S7-06-01  
Task No. 9004L100178000**

**DRAFT SAMPLING TRIP REPORT  
RIVERSIDE AVENUE SITE  
NEWARK, ESSEX COUNTY, NEW JERSEY**

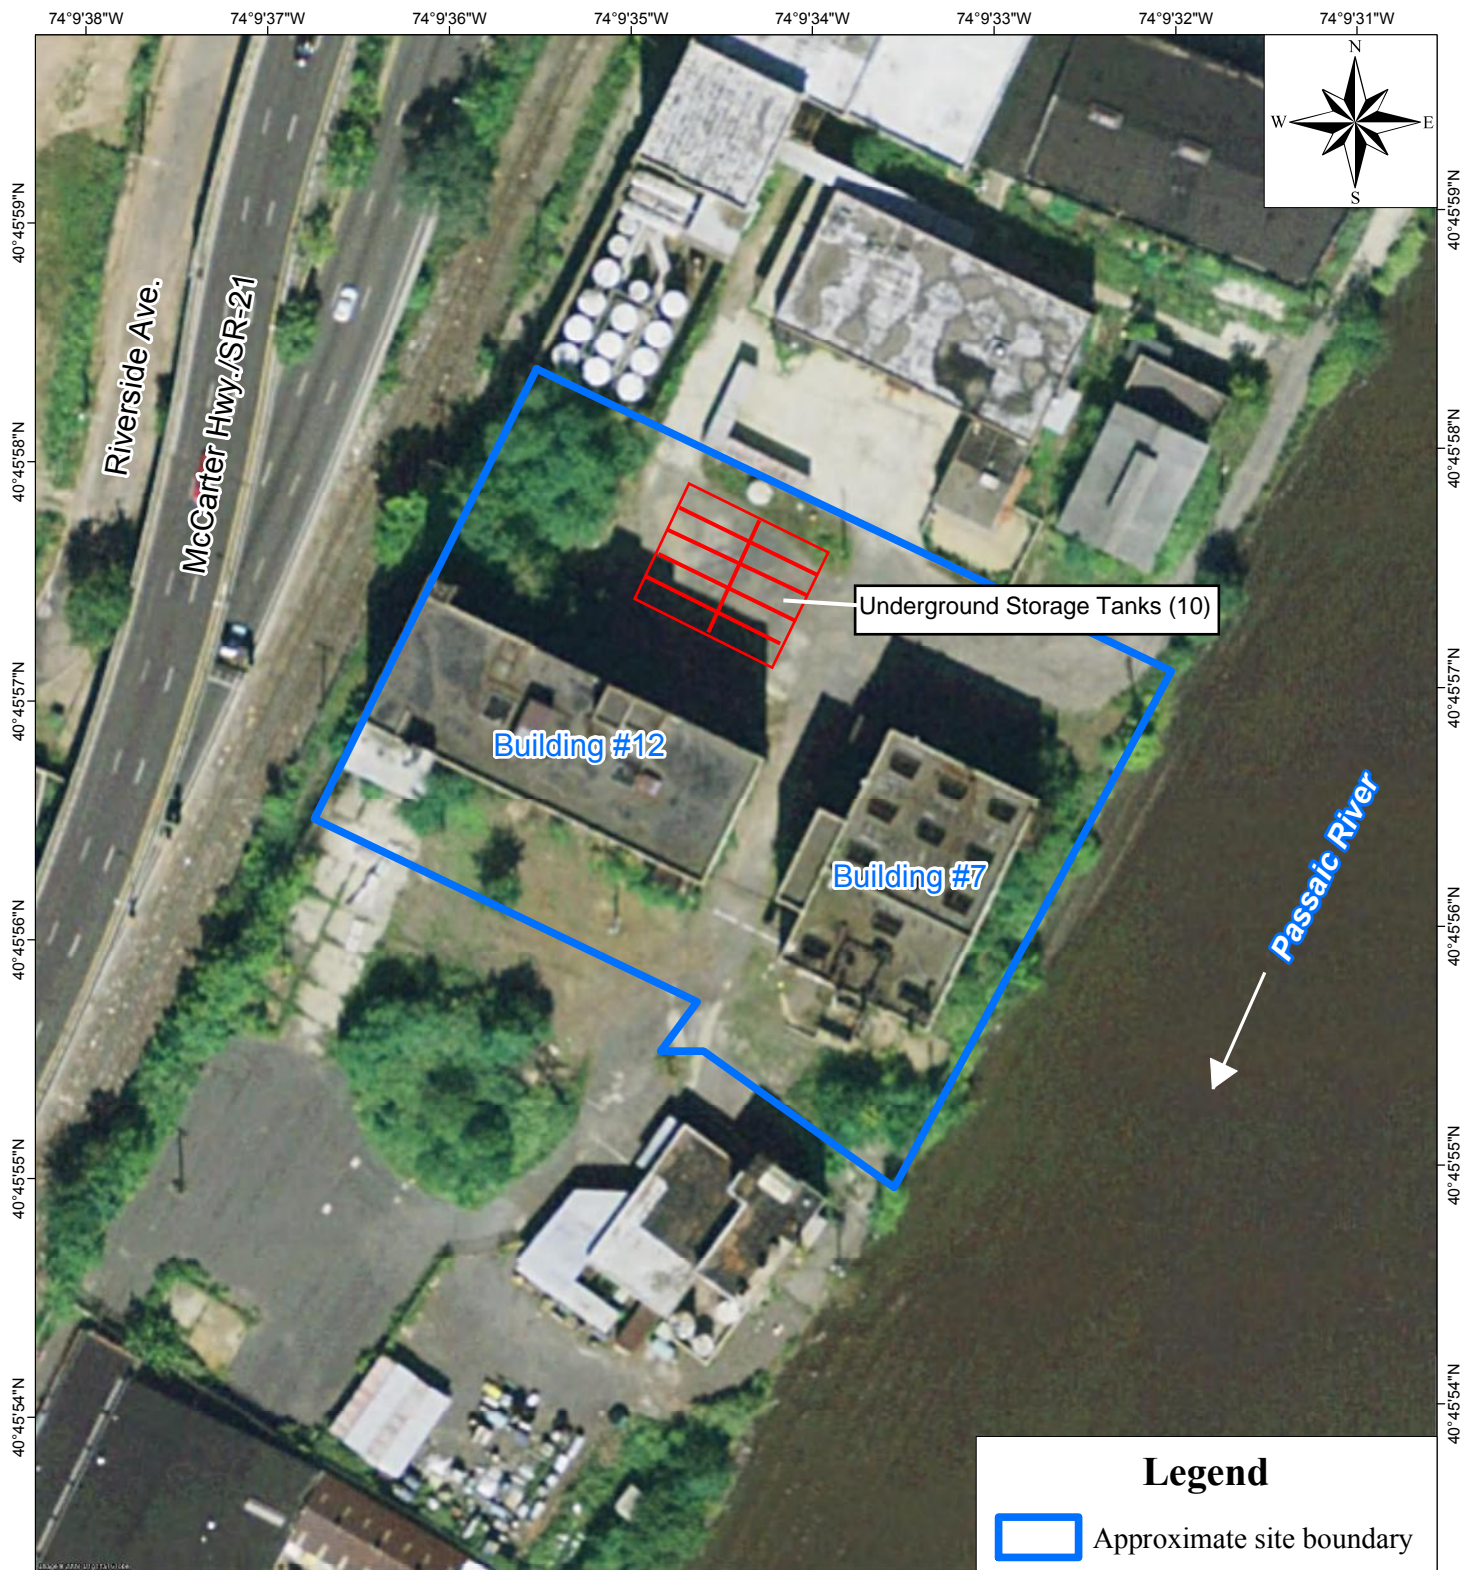
**Figure 2**  
Site Layout Map

The Riverside Avenue site is located off of McCarter Highway (New Jersey Route 21) on Riverside Avenue in Newark, New Jersey, as shown on Figure 1, Site Location Map, in Appendix A. The site is identified in the Comprehensive Environmental Response, Compensation, and Liability Information System (CERCLIS) as being located at 29 Riverside Avenue. The geographic coordinates for the approximate center of the site are 40° 45' 56.52" north latitude and 74° 9' 32.7594" west longitude. The area being investigated covers approximately 1/10 of 1 acre (5,000 square feet) on Lot 64 (Block 614) where 10 underground tanks are buried as shown on Figure 2, Site Layout Map, in Appendix A. Lot 64 is owned by the

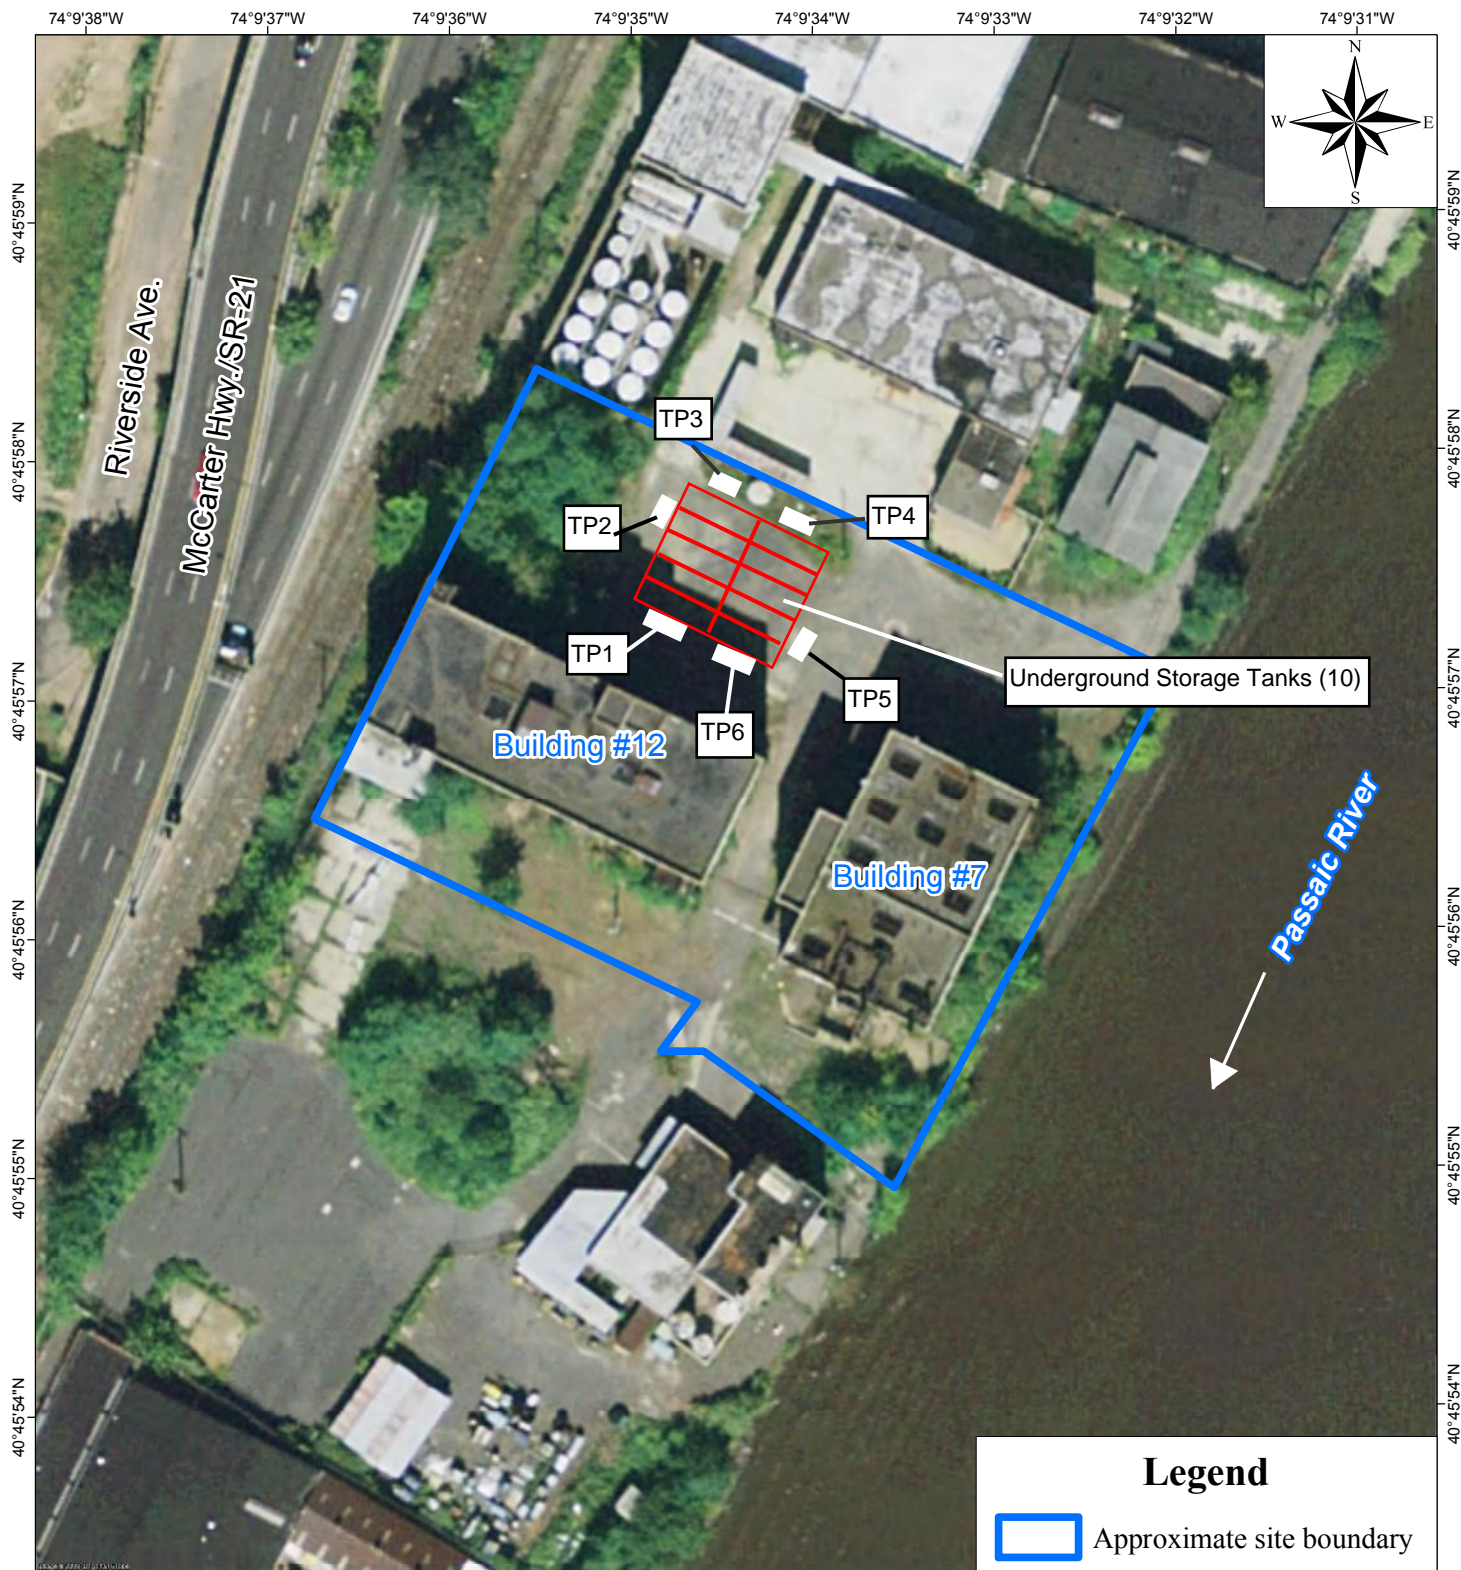
**Figure 3**  
Test Pit Location Map

Figure 3, Test Pit Location Map, in Appendix A shows the locations of the six test pits excavated along the perimeter of the UST farm. Test pits were identified as TP1 through TP6. Two test pits were excavated on each of the north and south sides of the UST perimeter and one test pit was excavated on each of the east and west sides. Table 1 in Appendix B is a summary of the samples collected from the six test pits, including the date and time of each sample collected; the test pit number and sample depth; the analytical parameter and method, and laboratory, chain-of-custody record number and air bill number.

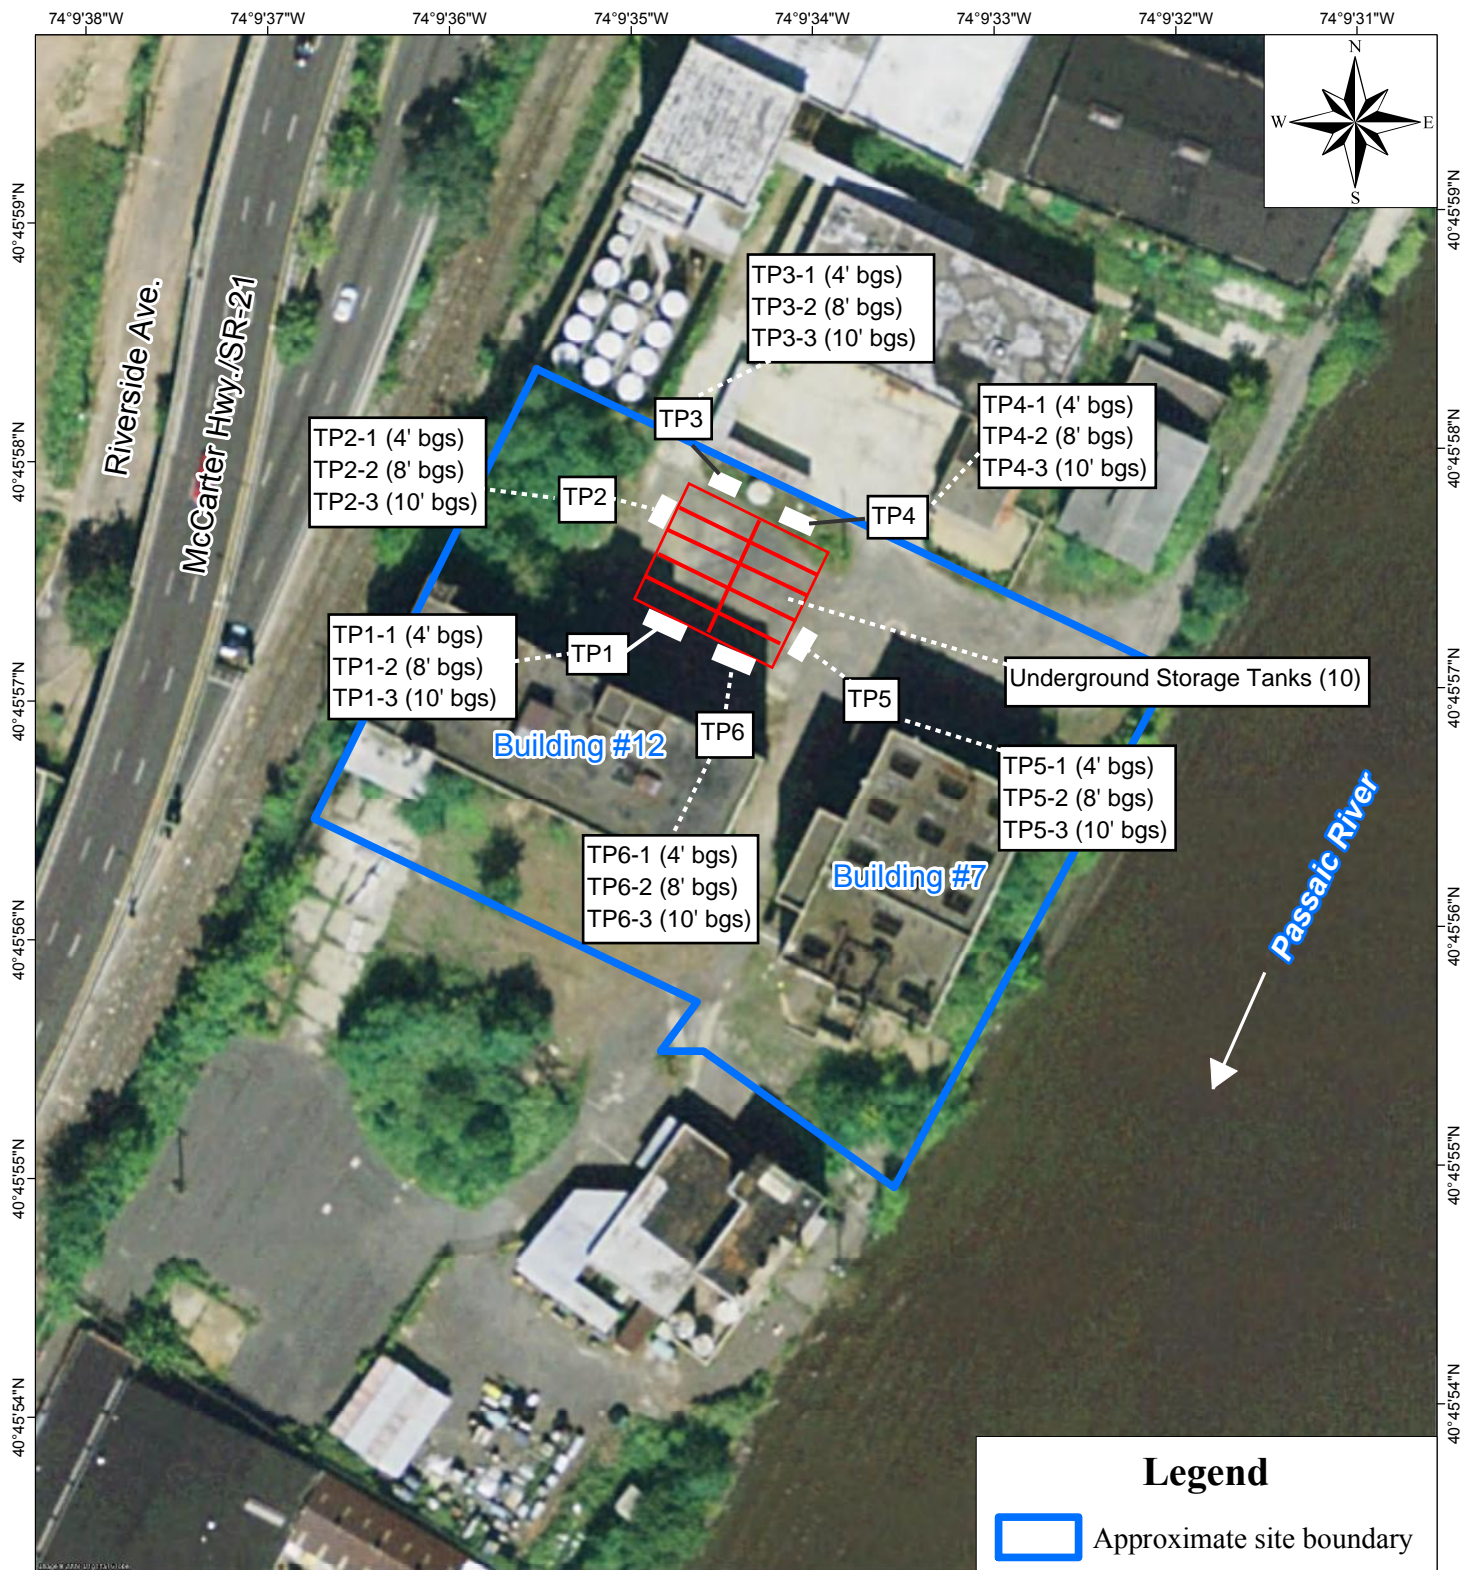
**Figure 4**  
Test Pit Sample Location Map

Figure 4 in Appendix A shows the sampling locations and depths. Tetra Tech obtained geographic coordinates for each of the sampling locations using Google Earth. The coordinates

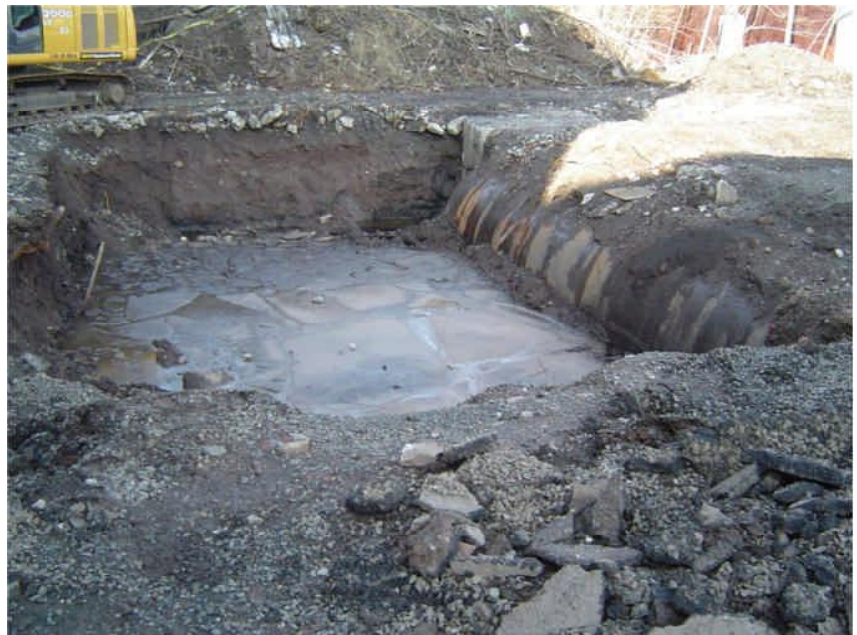
**Description:** Photograph shows pooled water in excavated area on Lot 64 in the area of the UST tank farm. One UST is visible in the photograph.

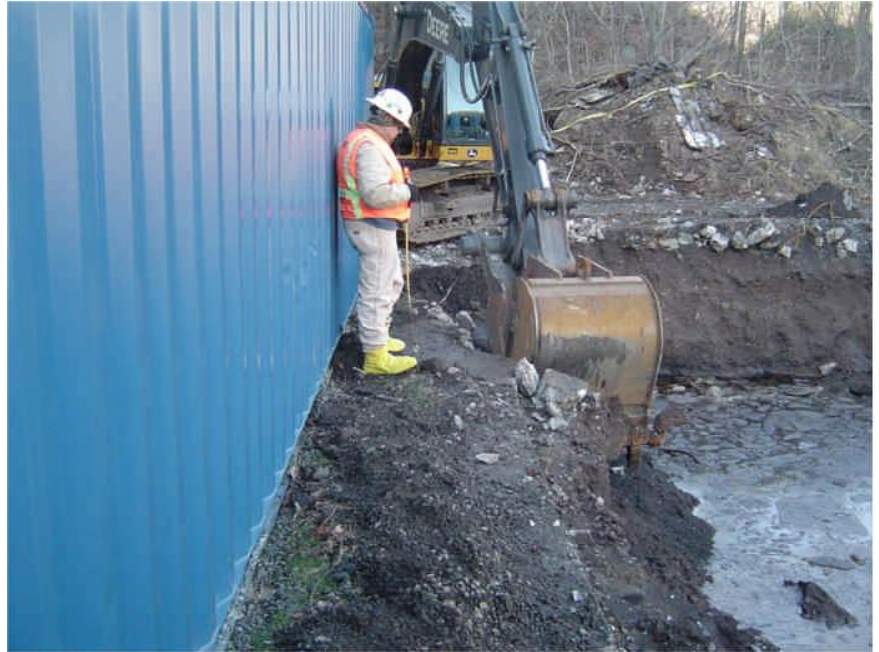
**Description:** Photograph shows ERRS operator excavating test pit TP1. ERRS Foreman is shown in foreground of photo with a tape measure to measure depth of excavation for sampling interval.

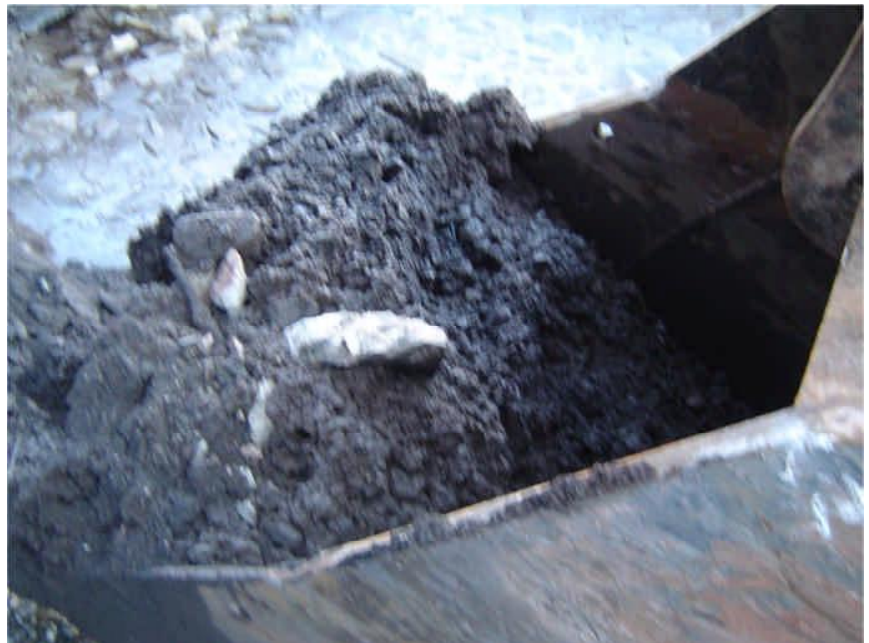
**Description:** Photograph shows soil in excavator bucket collected from a depth of 4' bgs in test pit TP1.

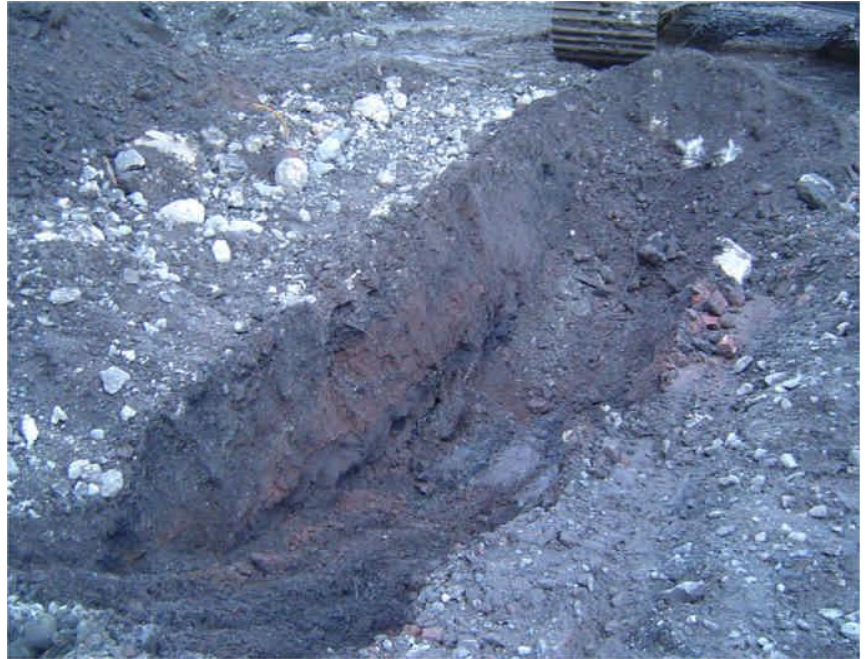
**Description:** Photograph shows initial excavation of test pit TP2.

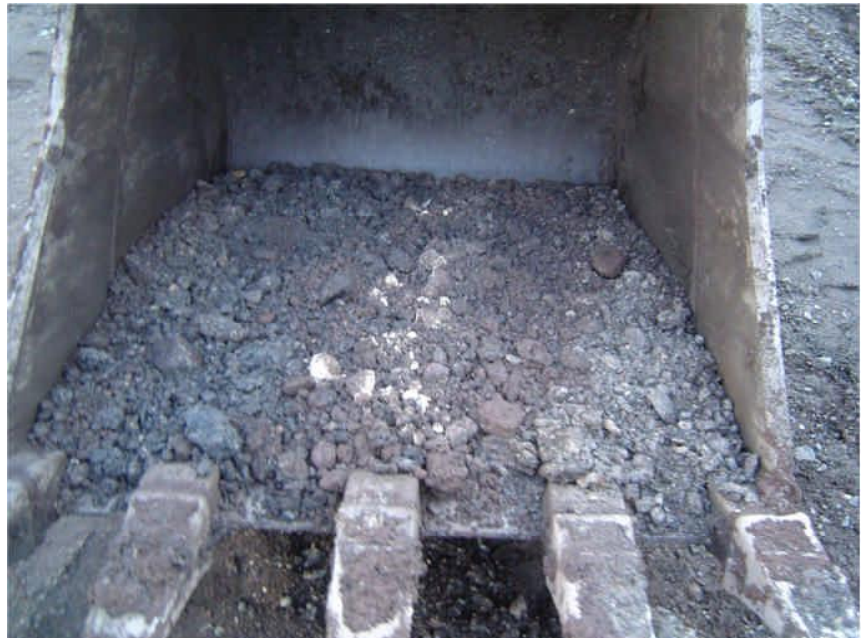
**Description:** Photograph shows soil in excavator bucket collected from a depth of 4' bgs in test pit TP2.

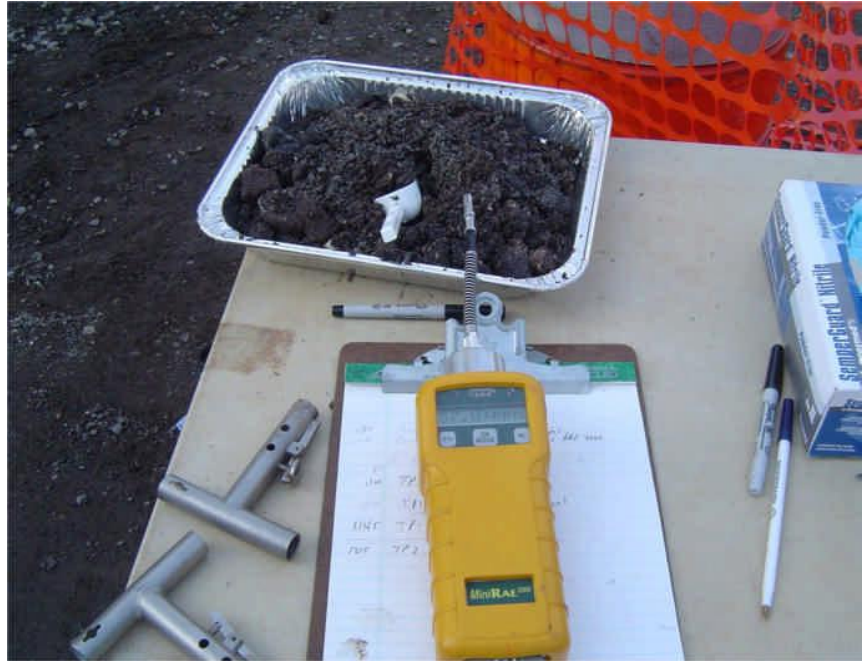
**Description:** Photographs shows soil sample collected from TP2 and PID used to screen soil samples for volatile organic compounds.

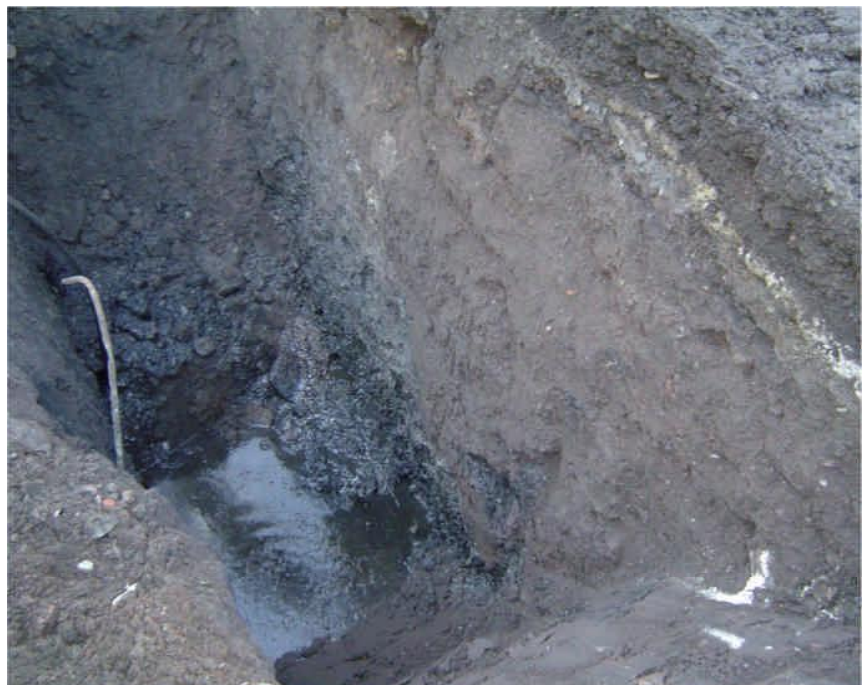
Dark, oil-stained fill material was encountered at all test pit locations and a strong petroleum odor was detected during the excavation of each test pit. A visible oily sheen was observed on the surface of pooled groundwater that accumulated in the bottom of each excavation. The water table was measured at a depth of approximately 6 feet bgs. A clay layer was determined to be present at approximately 11' bgs. All soil samples collected from the site did have notable visible contamination and notable petroleum odors. A pesticide odor was detected during the excavation of Test pit TP5.

**Description:** Looking down into test pit TP3. Excavation depth is approximately 8' bgs. Excavation is below water table (approx. 6' bgs). Black oily sheen is also visible in photo, floating on pooled water in excavation.

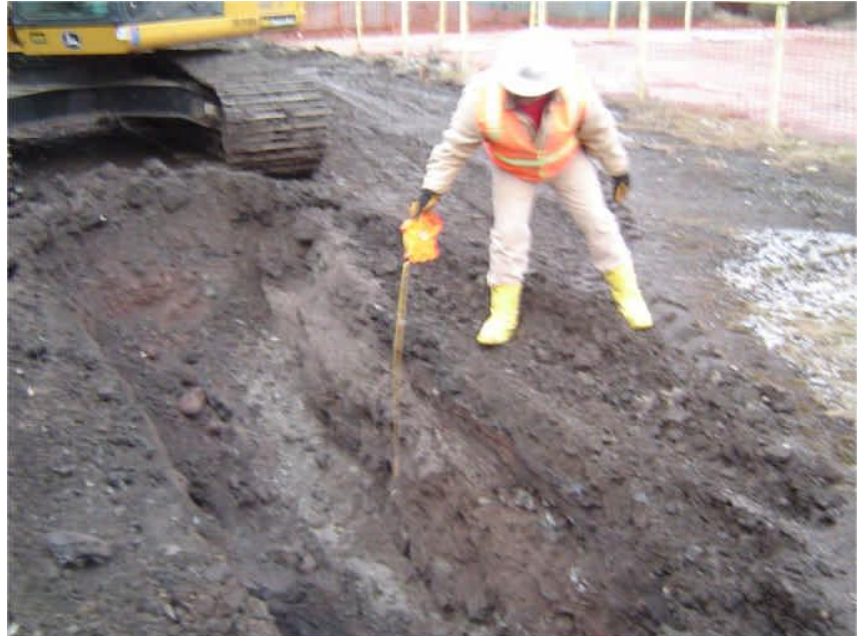
**Description:** Photos shows ERRS foreman measuring depth of excavation in test pit TP4.

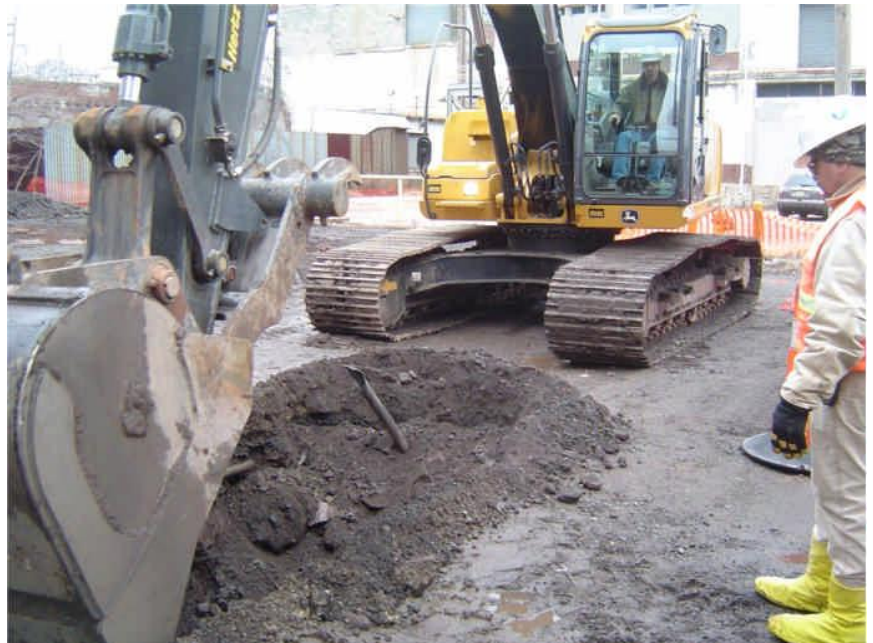
**Description:** Photograph shows initial exaction of test pit TP5.

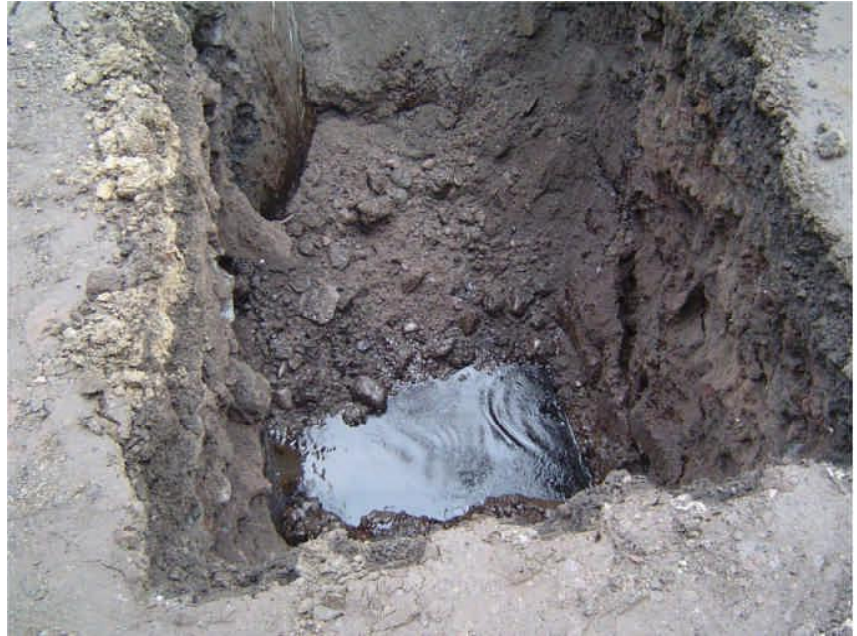
**Description:** Looking down into test pit TP5. Excavation depth is approximately 5' bgs. Black oily sheen is also visible in photo, floating on pooled water in excavation.

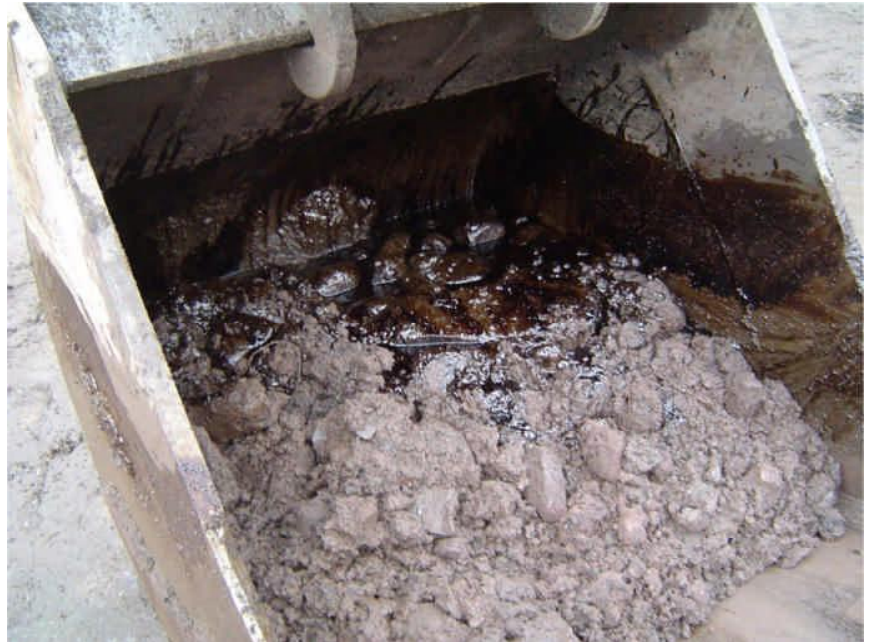
**Description:** Photograph shows soil in excavator bucket collected from a depth of 8' bgs in test pit TP5.

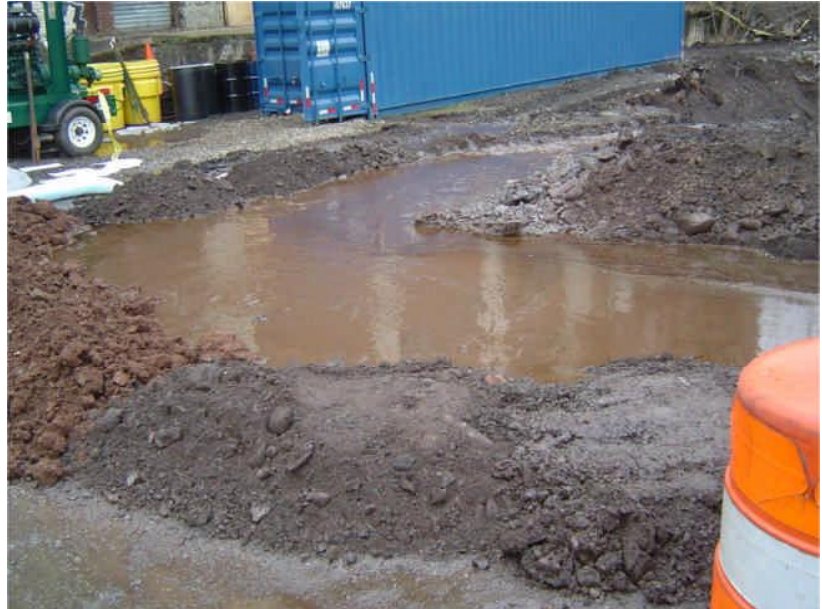
**Description:** Photograph shows test pit TP5 overflowing with water after 8 inch water main was damaged by the excavator bucket while attempting to excavate to 10' bgs. ERRS personnel quickly constructed an earthen berm and swale to channel water into open pit.

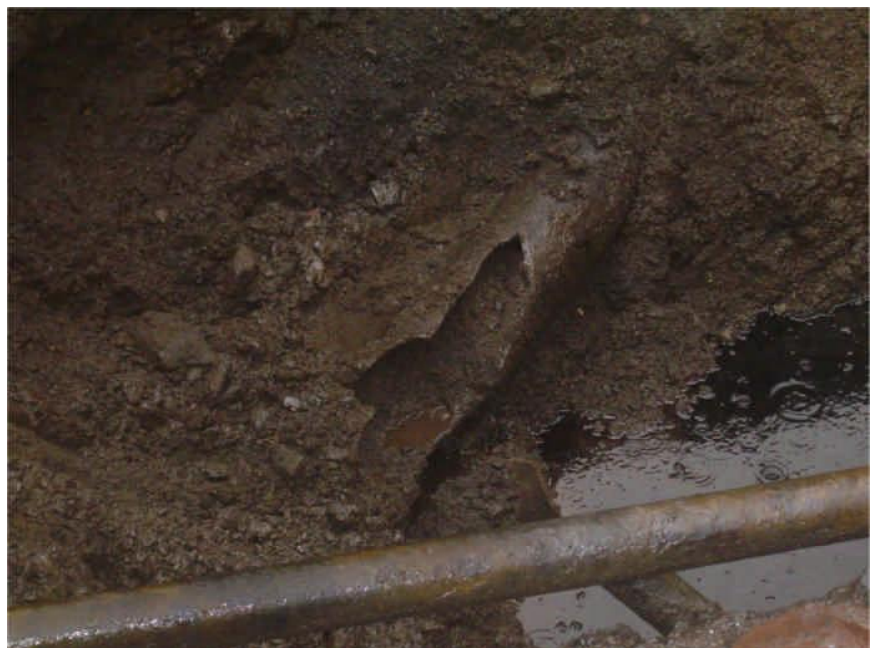
**Description:** Photograph shows the 8 inch water main that was damaged in test pit TP5, after the main had been turned off and the water pumped out of the excavation.
